# Manhole Inspection Summary

Manhole # S69S\_\_011MH

Insp Date: **4/1/08 2:33 PM**

**Location** Address: **1700 Manor Ave.**

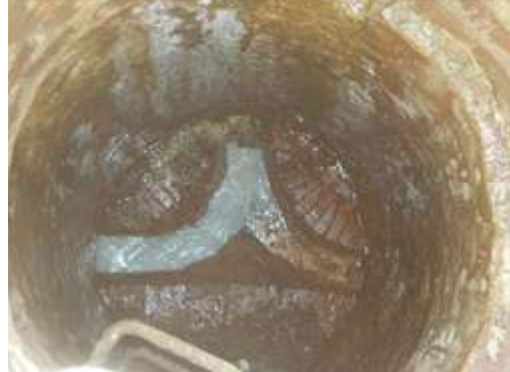
Top View

Comments **ACTIVE SURCHARGE PRESENT ON FIRST VISIT. 4-1-08**

☒ Evidence Of Surcharge Depth: **8** (ft.) ☒ Active Surcharge Present

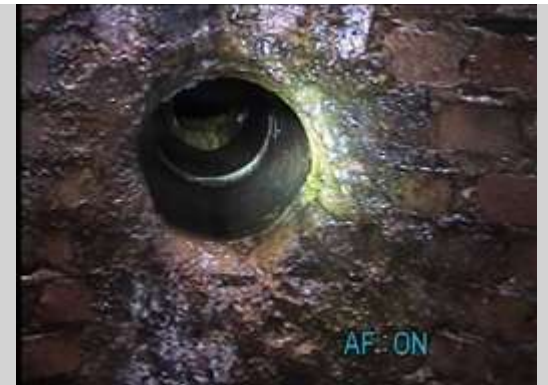
3 O'Clock Inflow

8 in. Circular Gravity Sewer  
Pipe In @ 3 O'Clock

Drop In @ 3 O'Clock

Drop: **Inside** Rod and Bar  
Angled: **Yes** Reading: **14.13** (ft.)  
Inv Depth: **15.13** (ft.)

Drop Condition: **Open**

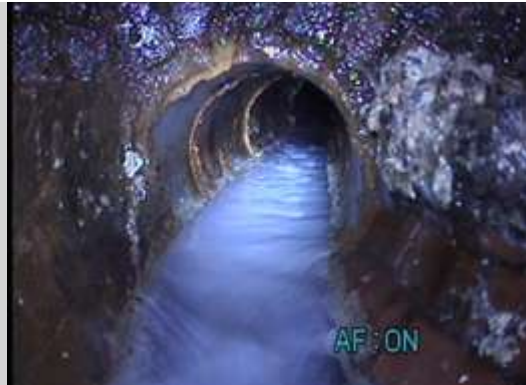
9 O'Clock Inflow

10 in. Circular Gravity Sewer

Pipe In @ 9 O'Clock
